SAND2003-3430

## **Assessment of the Non-Destructive Nature of PASD on Wire Insulation Integrity**

The potential of a new cable diagnostic known as Pulse-Arrested Spark Discharge technique (PASD) is being studied. Previous reports have documented the capability of the technique to locate cable failures using a short high voltage pulse<sup>1</sup>. This report will investigate the impact of PASD on the sample under test. In this report, two different energy deposition experiments are discussed. These experiments include the PASD pulse (~6 mJ) and a high energy discharge (~600 mJ) produced from a charged capacitor source. The high energy experiment is used to inflict detectable damage upon the insulators and to make comparisons with the effects of the low energy PASD pulse. Insulator breakdown voltage strength before and after application of the PASD pulse and high energy discharges are compared. Results indicate that the PASD technique does not appear to degrade the breakdown strength of the insulator or to produce visible damage. However, testing of the additional materials, including connector insulators, may be warranted to verify PASDs non-destructive nature across the full sp

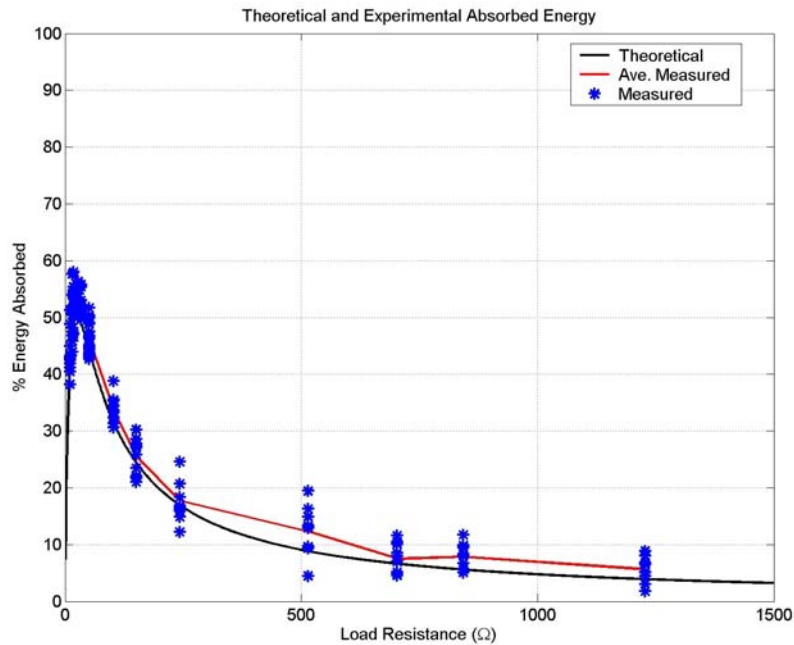
Figure 10 shows the theoretical and measured energy absorbed as the load resistance is varied. The experimental data is in good agreement with the theory over a wide range of impedances. There is less than a 5% difference in the average measured energy absorbed compared to the theoretical values. This demonstrates the capability of the system to measure energy deposition over a wide range as is necessary for the arc measurements. The difference between the experimental measurements and calculations at high impedance is due to the electrical noise in the system. This has a small effect on the arc measurements.

Figure 10. Plots of experimentally measured and calculated energy absorbed for known load resistances.

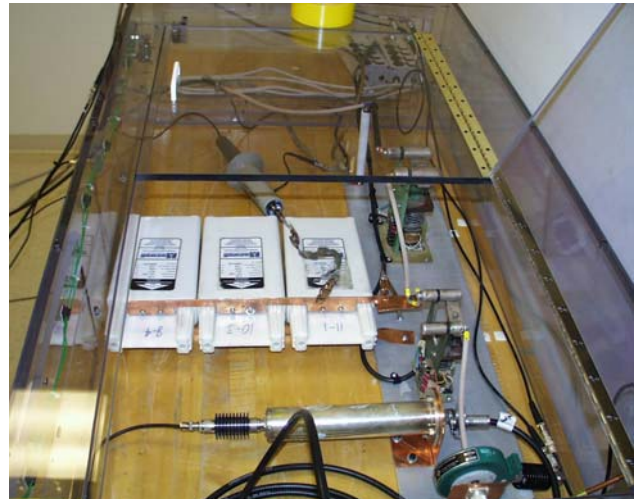
Figure 12. Large energy deposition experimental layout. Energy storage capacitors are white objects in center, current monitors are shown below.

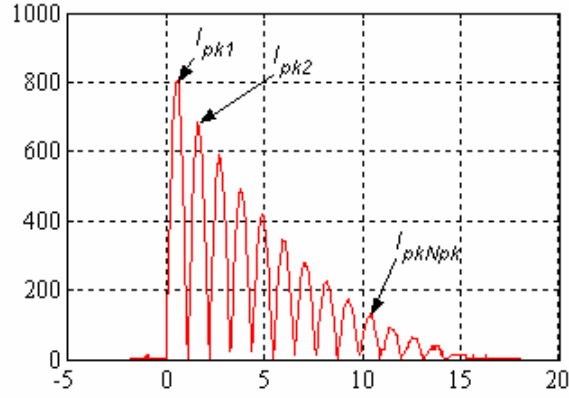
Figure 17. Absolute value of the measured current.

4. The damping coefficient is determined next. First take the absolute value of the measured current as shown in Figure 17. Then determine the peak value of the current ( $I_{pk}$ ) from  $N_{pk}$  half cycles along with the time at which the peaks occur ( $T_{pk}$ ). The damping ratio is then calculated by

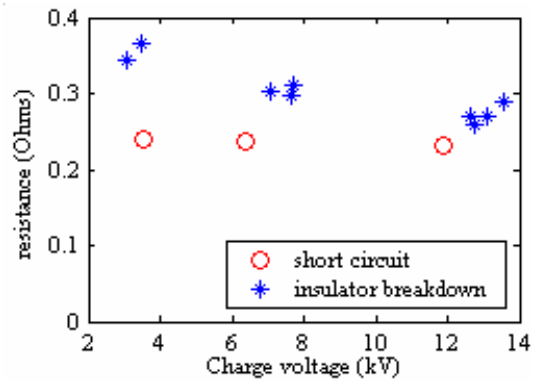
Figure 20. Estimated resistance versus capacitor charge voltage.

Using the resistances plotted in Figure 20 and the measured currents the sample resistances and energies dissipated, during breakdown, are calculated resulting in the values plotted in Figure 21 and Figure 22. Consistent with the results in Figure 20 the arc/sample resistance decreases with increasing charge voltage. This would seem to indicate that at greater charge voltages it should be more difficult to deliver energy to the arc, which is contradicted by Figure 22. However, what maybe happening is that for larger charge voltages the arc remains in a low impedance state for longer periods of time resulting in a lower estimated resistance.

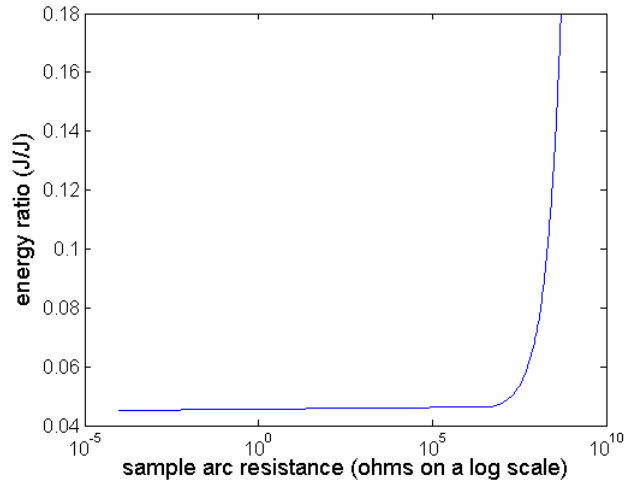
Figure 24. Ratio of the low energy discharge arc energy to the PASD pulse arc energy versus arc resistance.

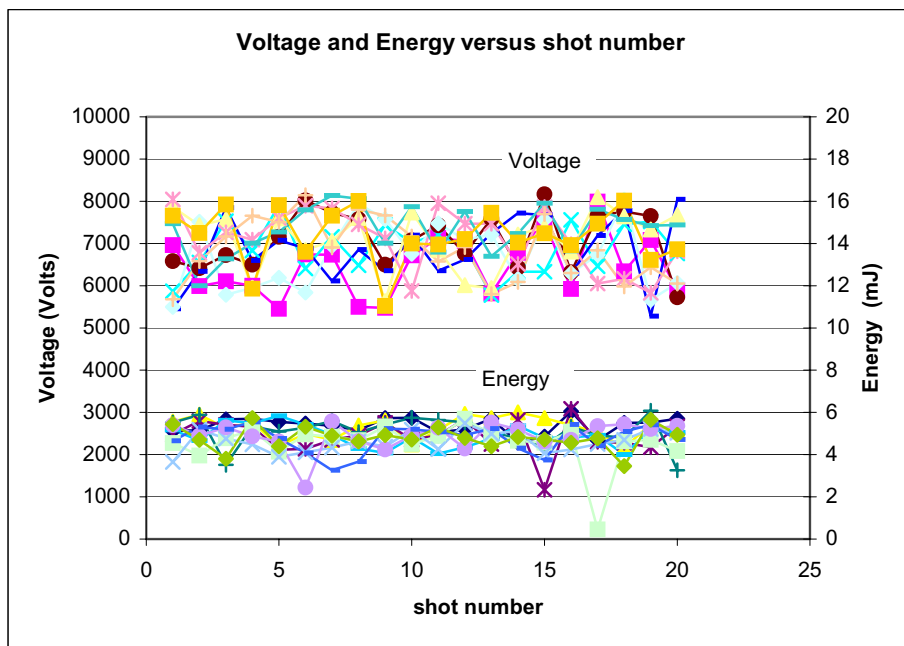
Figure 28. In this figure, the breakdown voltage and energy deposited into the discharge are plotted versus shot number. Note that there is no significant change in breakdown voltage after the first shot, and no trend towards lower voltage as the shot series progresses. This is a clear indication that no damage is occurring to the insulator surface under test.

Figure 28. Breakdown voltage and deposited energy versus shot number

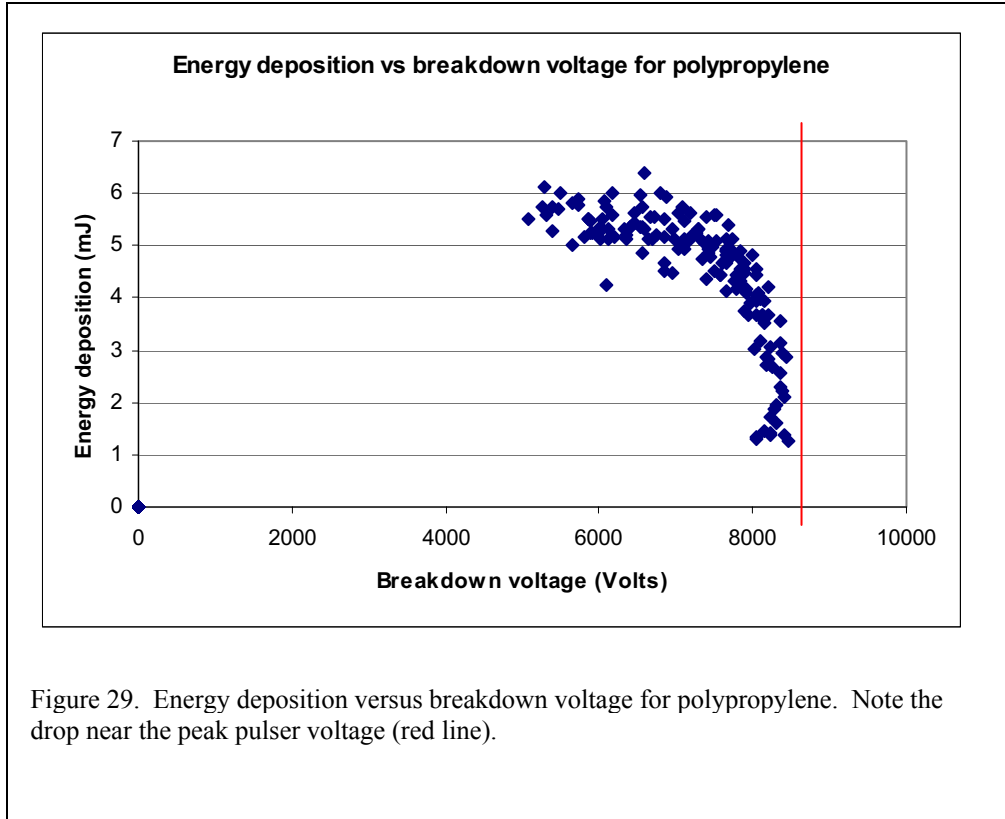
It was observed that the timing of the breakdown changed the energy deposition. Figure 29 shows the variation in energy deposition versus voltage breakdown for the 200 shots fired in configuration C using polypropylene. There is a significant drop in the deposited energy as the breakdown approaches the peak pulser voltage. This is not due to the breakdown voltage directly, but the timing of the arc in the input pulse. For breakdown near the peak voltage, the input pulse is falling during the surface breakdown. This drops the available input power during breakdown and ultimately the total power delivered to the arc. A similar effect would be observed if the pulse length were shortened. This would also lead to a drop in the deposited energy, but could lead to reduced reliability since the number of shots without a breakdown would increase (as seen from the no breakdown data).

Figure 29. Energy deposition versus breakdown voltage for polypropylene. Note the drop near the peak pulser voltage (red line).

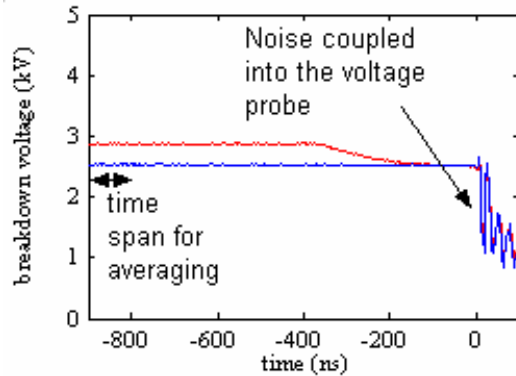
Due to the sometimes erratic behavior of the voltage breakdown process some of the measured voltage waveforms had unusual shapes, as can be seen in Figure 30. For this reason the average of the voltage waveforms before any fluctuations began was taken as the breakdown voltage.

Figure 30. Example of measured voltages during two different low energy breakdown experiments.

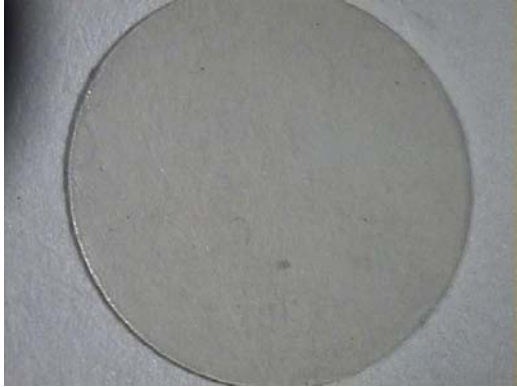
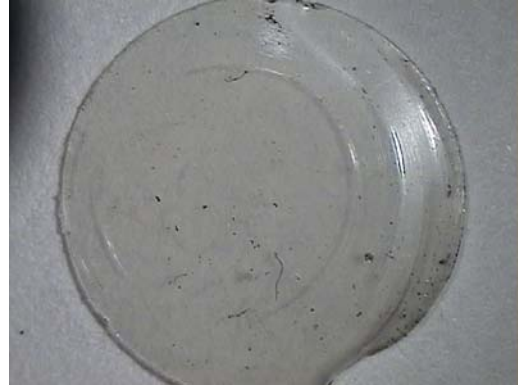
Figure 51 and Figure 52 contain photographs of a mylar sample before and after a low energy discharge. Notice the contamination (specs) apparent in Figure 52 following the low energy discharge. Since this contamination is located in areas not in the discharge path they were likely to have been in the fixture prior to the test. The important item to note is the lack of evidence in the photograph of damage to the insulator as a result of the discharge.

Figure 51. Microscopic photograph of a mylar sample before a low energy breakdown.

Figure 52. Microscopic photograph of a mylar sample after a low energy breakdown.

Additionally, since an understanding of the source of the specks of contamination seen in Figure 52, Figure 54, and Figure 56 is not known, further tests involving before and after photographs are recommended in order to determine any patterns and the probable source.

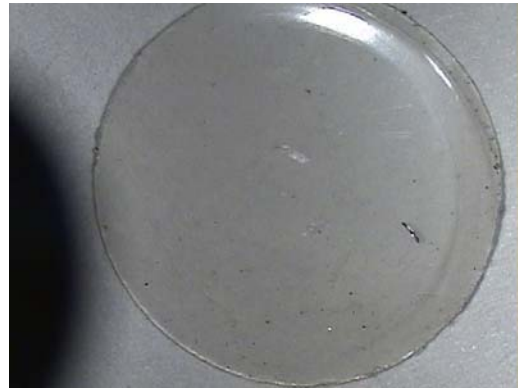
Figure 53 and Figure 54 contain photographs of a mylar sample before and after a PASD pulse. Notice the contamination (specs) apparent in Figure 54 following the PASD pulse. This contamination is significantly less than the contamination apparent in Figure 52. It is unclear whether the PASD pulse removed some of the contamination or there was less contamination in the fixture during the test. Again the important item to note is the lack of evidence in the photograph of damage to the insulator as a result of the discharge.

Figure 53. Microscopic photograph of a mylar sample before a PASD pulse.

Figure 54. Microscopic photograph of a mylar sample after a PASD pulse.

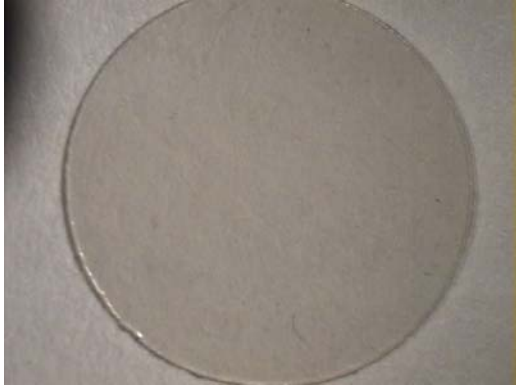
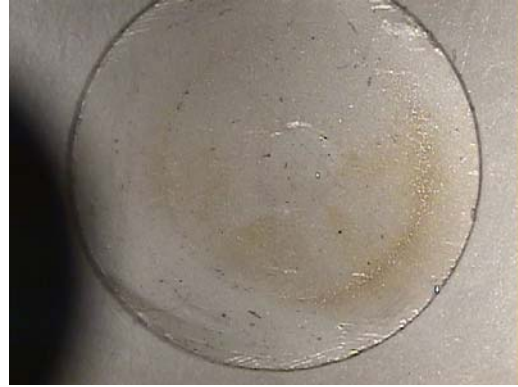
Figure 55 and Figure 56 contain photographs of a mylar sample before and after a high energy discharge. Notice the material deposition apparent in Figure 56. This material deposition is suspected to be metal removed from the BNC connector pin depicted in Figure 6. This deterioration is evident by looking at the photograph of this pin in Figure 57. This deposition supports the observation section 3.3 of the high energy discharge affecting the low energy voltage breakdown of the mylar samples.

Figure 55. Microscopic photograph of a mylar sample before a high energy discharge.

Figure 56. Microscopic photograph of a mylar sample after a high energy discharge.

Unlike the PASD pulse, the high energy discharge was found to affect the insulator samples. The variation in the low energy breakdown voltage was observed to decrease and material deposition was visible when viewed under a microscopic.

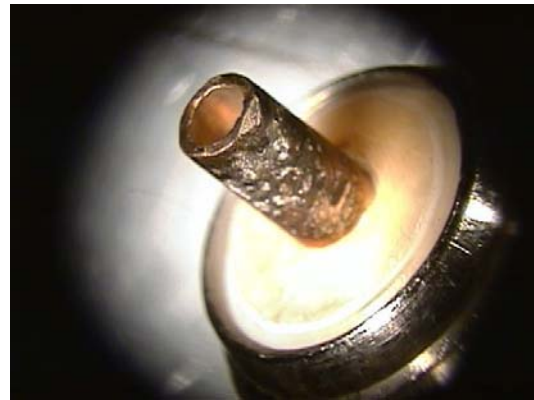
Figure 57. BNC connector pin located in the arc test fixture.
