The Potential of Prognostics for Preventative Maintenance of Electrical Wiring

Abstract

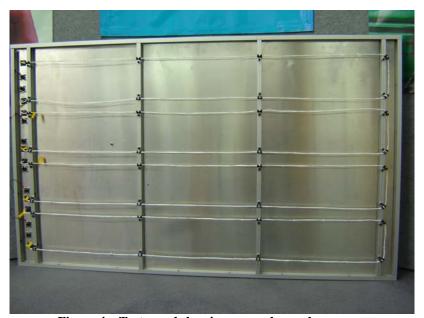
Figure 4 – Test panel showing properly run harnesses.

Each panel has eight mounted wire harnesses (four on each side). Four properly run harnesses are run on one side, and four harnesses with different wiring anomalies are run on the other side. Figure 4 is a photo showing the properly run wires. The wires use the proper clamps and have no other problems.

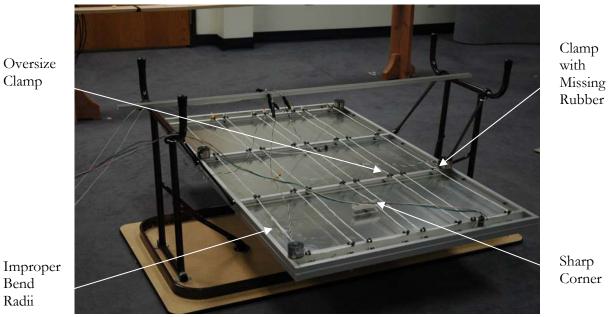
Figure 13 – Test panel 1 harness anomalies.
